Product Information Bulletin

BULLETIN NO.	230
ISSUED:	September 12, 2007
REPLACES:	NEW

Slope Stabilization Using GeoSpec® Lightweight Fill Material

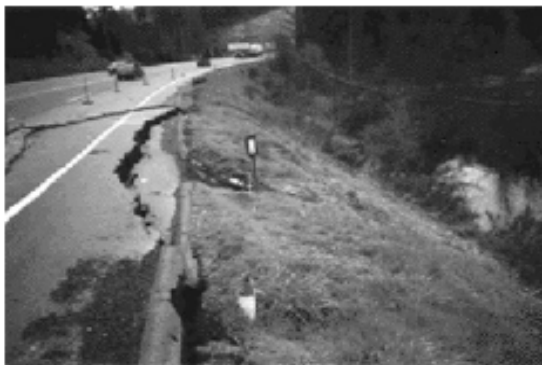
Road Section Before Repair

The Province of BC, Ministry of Transportation and Highways, Nanaimo Office, sought a performance solution to reconstruct a section of highway, which had been subject to reoccurring side slope failure. This section of highway had been repaired unsuccessfully a number of times previously by filling and resurfacing the failed road section. In this instance, the side slope had failed resulting in a portion of the road surface dropping by up to 305 mm (12") and

close proximity of the lake was seen to increase the likelihood of the side slope failure reoccurring.

The Ministry sought a long-term performance solution to resolve the problem. The corrective measure taken was to excavate the section of road down to hardpan. GeoSpec lightweight fill material blocks 1220 x 4880 x 900 mm (4 feet by 16 feet x 3 feet) were supplied to replace a portion of the failed soil embankment.

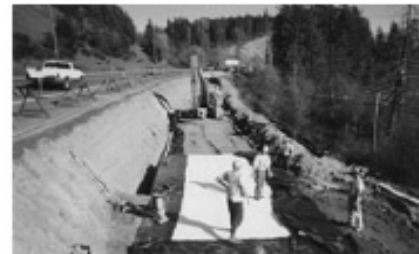
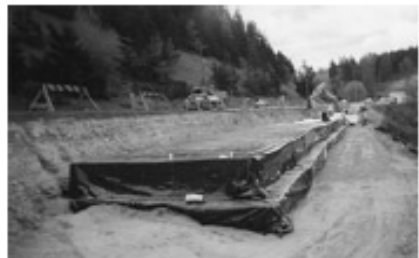
Installation of GeoSpec
Lightweight fill Material

The blocks were delivered to the site on flat bed trailers, unloaded using a small bobcat, and then placed in their final position on the prepared roadbed by hand. The road construction crew backfilled over the GeoSpec blocks as they were placed.
