# **Product Information Bulletin**

# **230**

## **Slope Stabilization Using GeoSpec Lightweight Fill Material**

### Slope Stabilization Using GeoSpec® Lightweight Fill Material

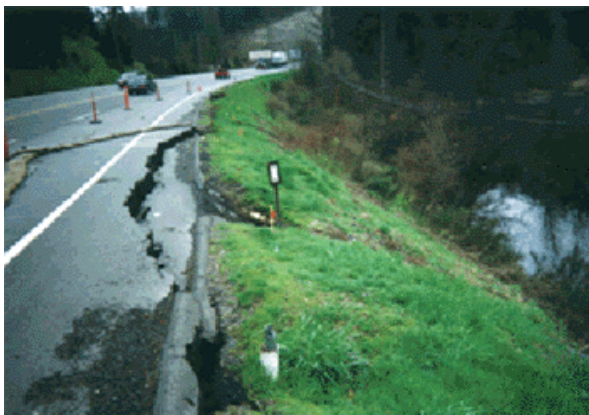
**Figure 1 - Road Section Before Repair**

The Province of BC, Ministry of Transportation and Highways, Nanaimo Office, sought a performance solution to reconstruct a section of highway, which had been subject to reoccurring side slope failure (Figure 1). This section of highway had been repaired unsuccessfully a number of times previously by filling and resurfacing the failed road section. In this instance, the side slope had failed resulting in a portion of the road surface dropping by up to 305 mm (12").

close proximity of the lake was seen to increase the likelihood of the side slope failure reoccurring.

The Ministry sought a long-term performance solution to resolve the problem. The corrective measure taken was to excavate the section of road down to hardpan. GeoSpec lightweight fill material blocks were supplied to replace a portion of the failed soil embankment (Figure 2).

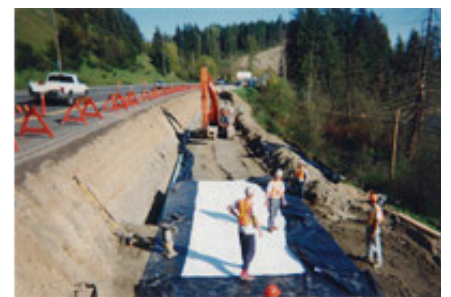
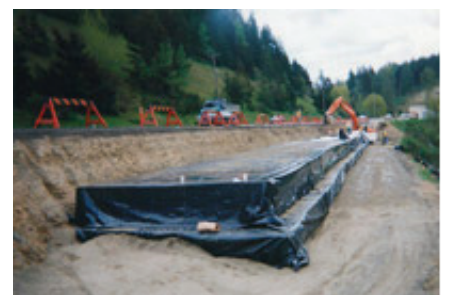
**Figure 2 Installation of GeoSpec Lightweight fill Material**

The blocks were delivered to the site on flat bed trailers, unloaded using a small bobcat, and then placed in their final position on the prepared roadbed by hand. The road construction crew backfilled over the GeoSpec blocks as they were placed.
